Long-Term Vibration Monitoring Interim Report No.4

North Kent Wind 1, Chatham-Kent, Ontario

1668031-4000-R04-Rev3

December 2021

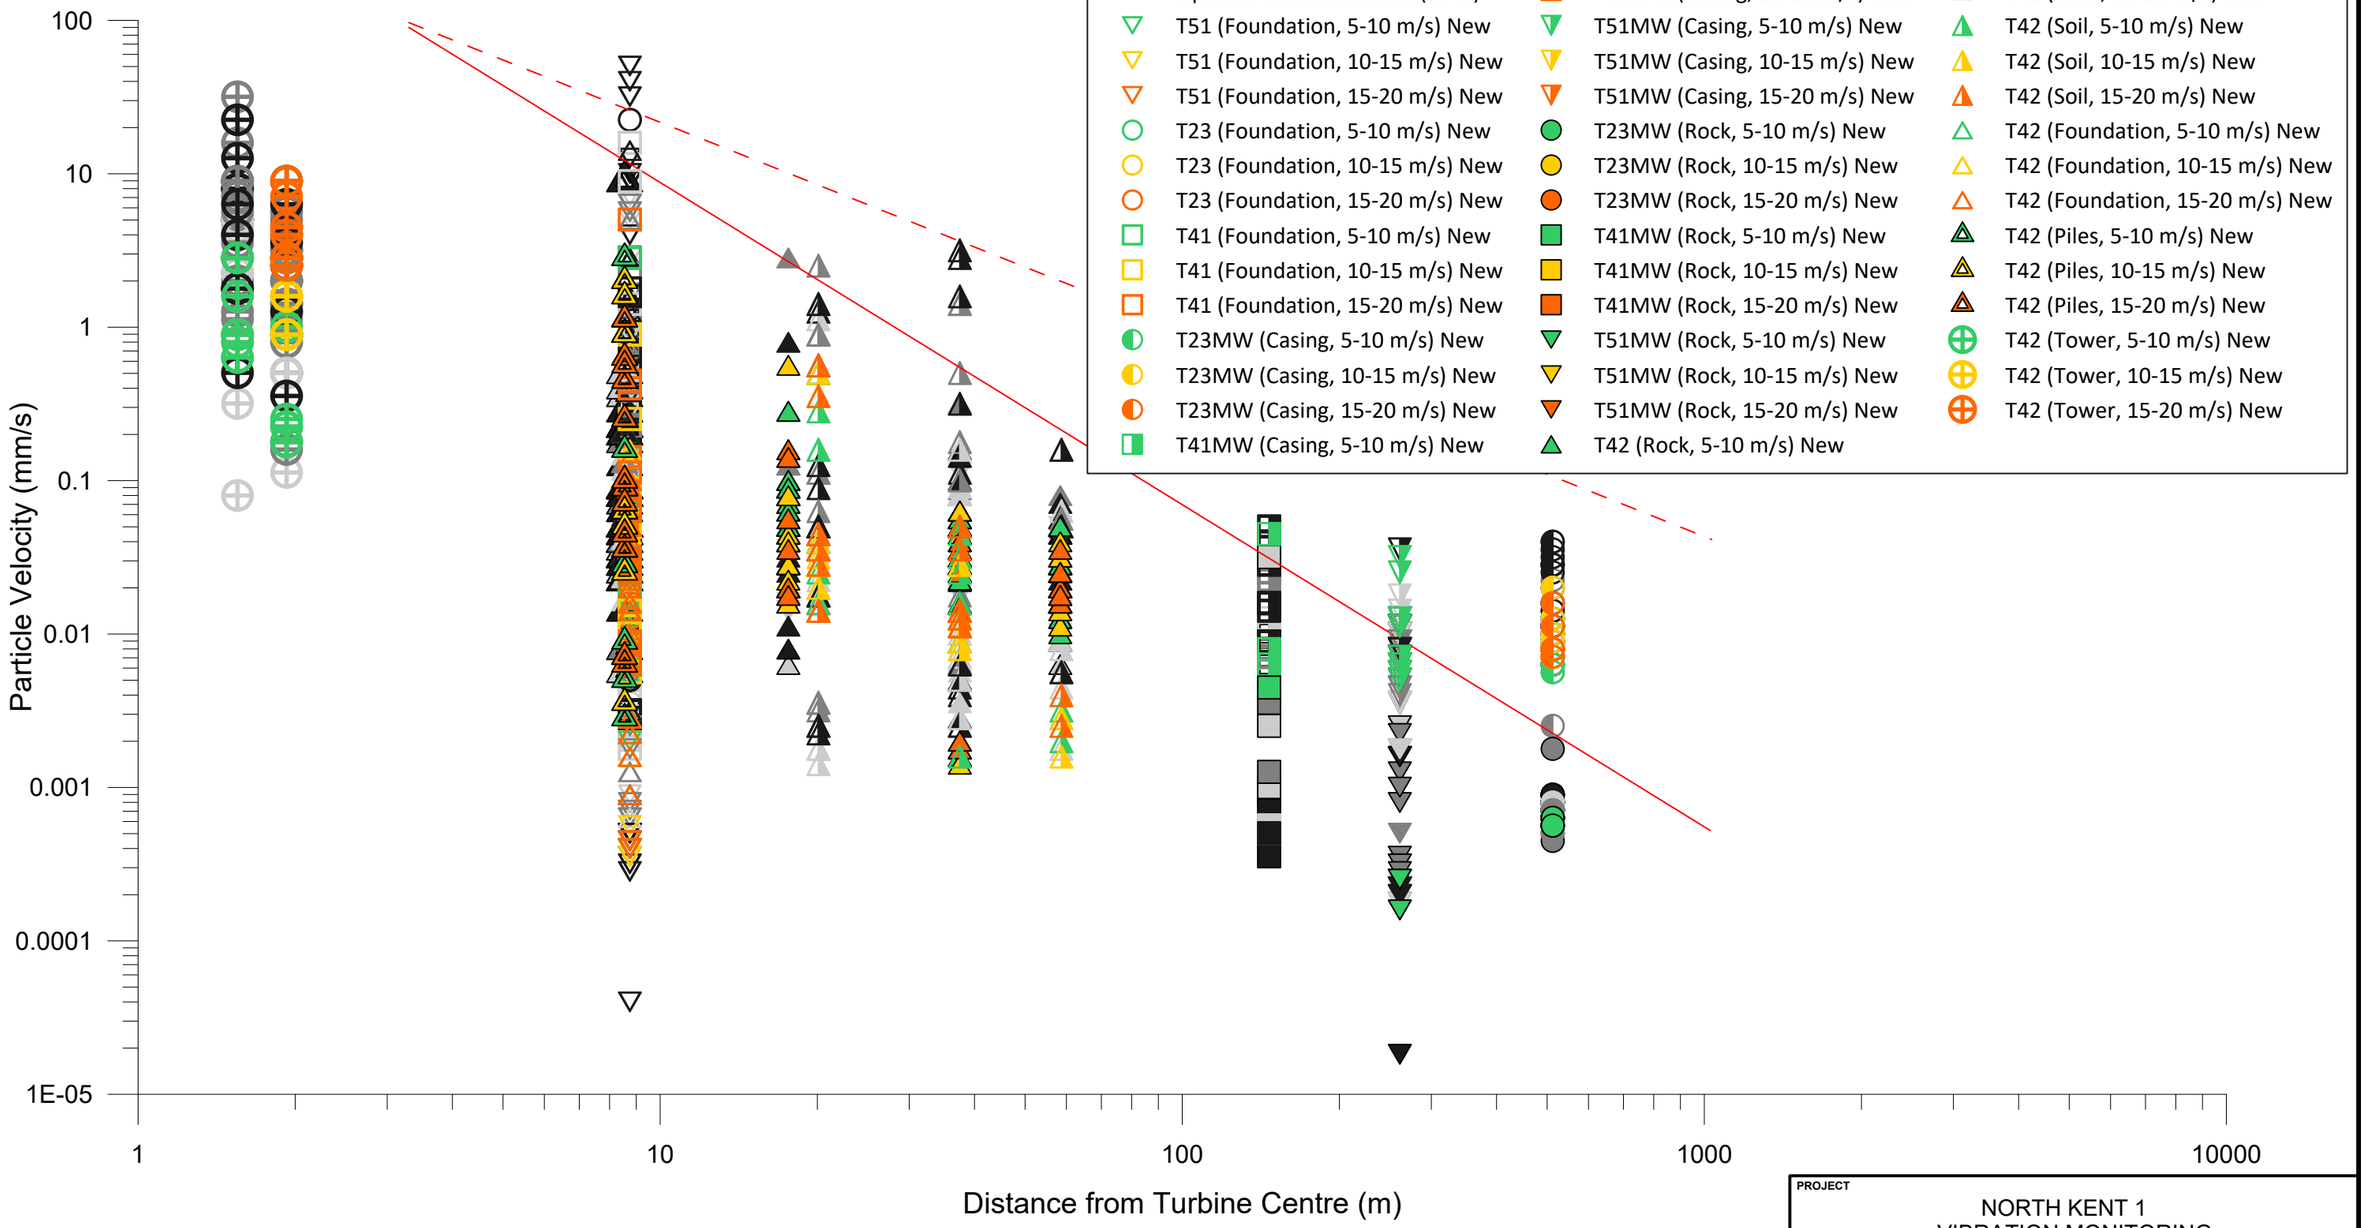
FIGURE 6

Data selected for analysis was processed and analysed following the procedures covered in Section 6.0 of Report No. 1. The dates picked for the analyses are shown on Figure 6. The results from the data analysis are presented on Figures 9A through 9D where the particle velocity (tower, turbine foundation, mock well casing or rock) is illustrated as related to the distance from the turbine tower centre. In this case, the data closest to the centre represent the measurements made by the accelerometers mounted within the tower (off set approximately 1.9 m from the centre). The instruments mounted on the foundations are approximately 7.9 m from the turbine tower centre. Also shown in Figures 9A to 9D are the results obtained for the first twenty-two months of vibration monitoring documented in Reports No. 1, 2 and 3 for comparison. These results are presented in grey colour scale as follows: light grey for low wind velocities (5 to 10 m/s), medium grey for moderate velocities (10 to 15 m/s), and dark grey for high velocity wind events (15 to 20 m/s). Data obtained during the period covered by this report are illustrated in full colour to facilitate comparison among the reporting periods.

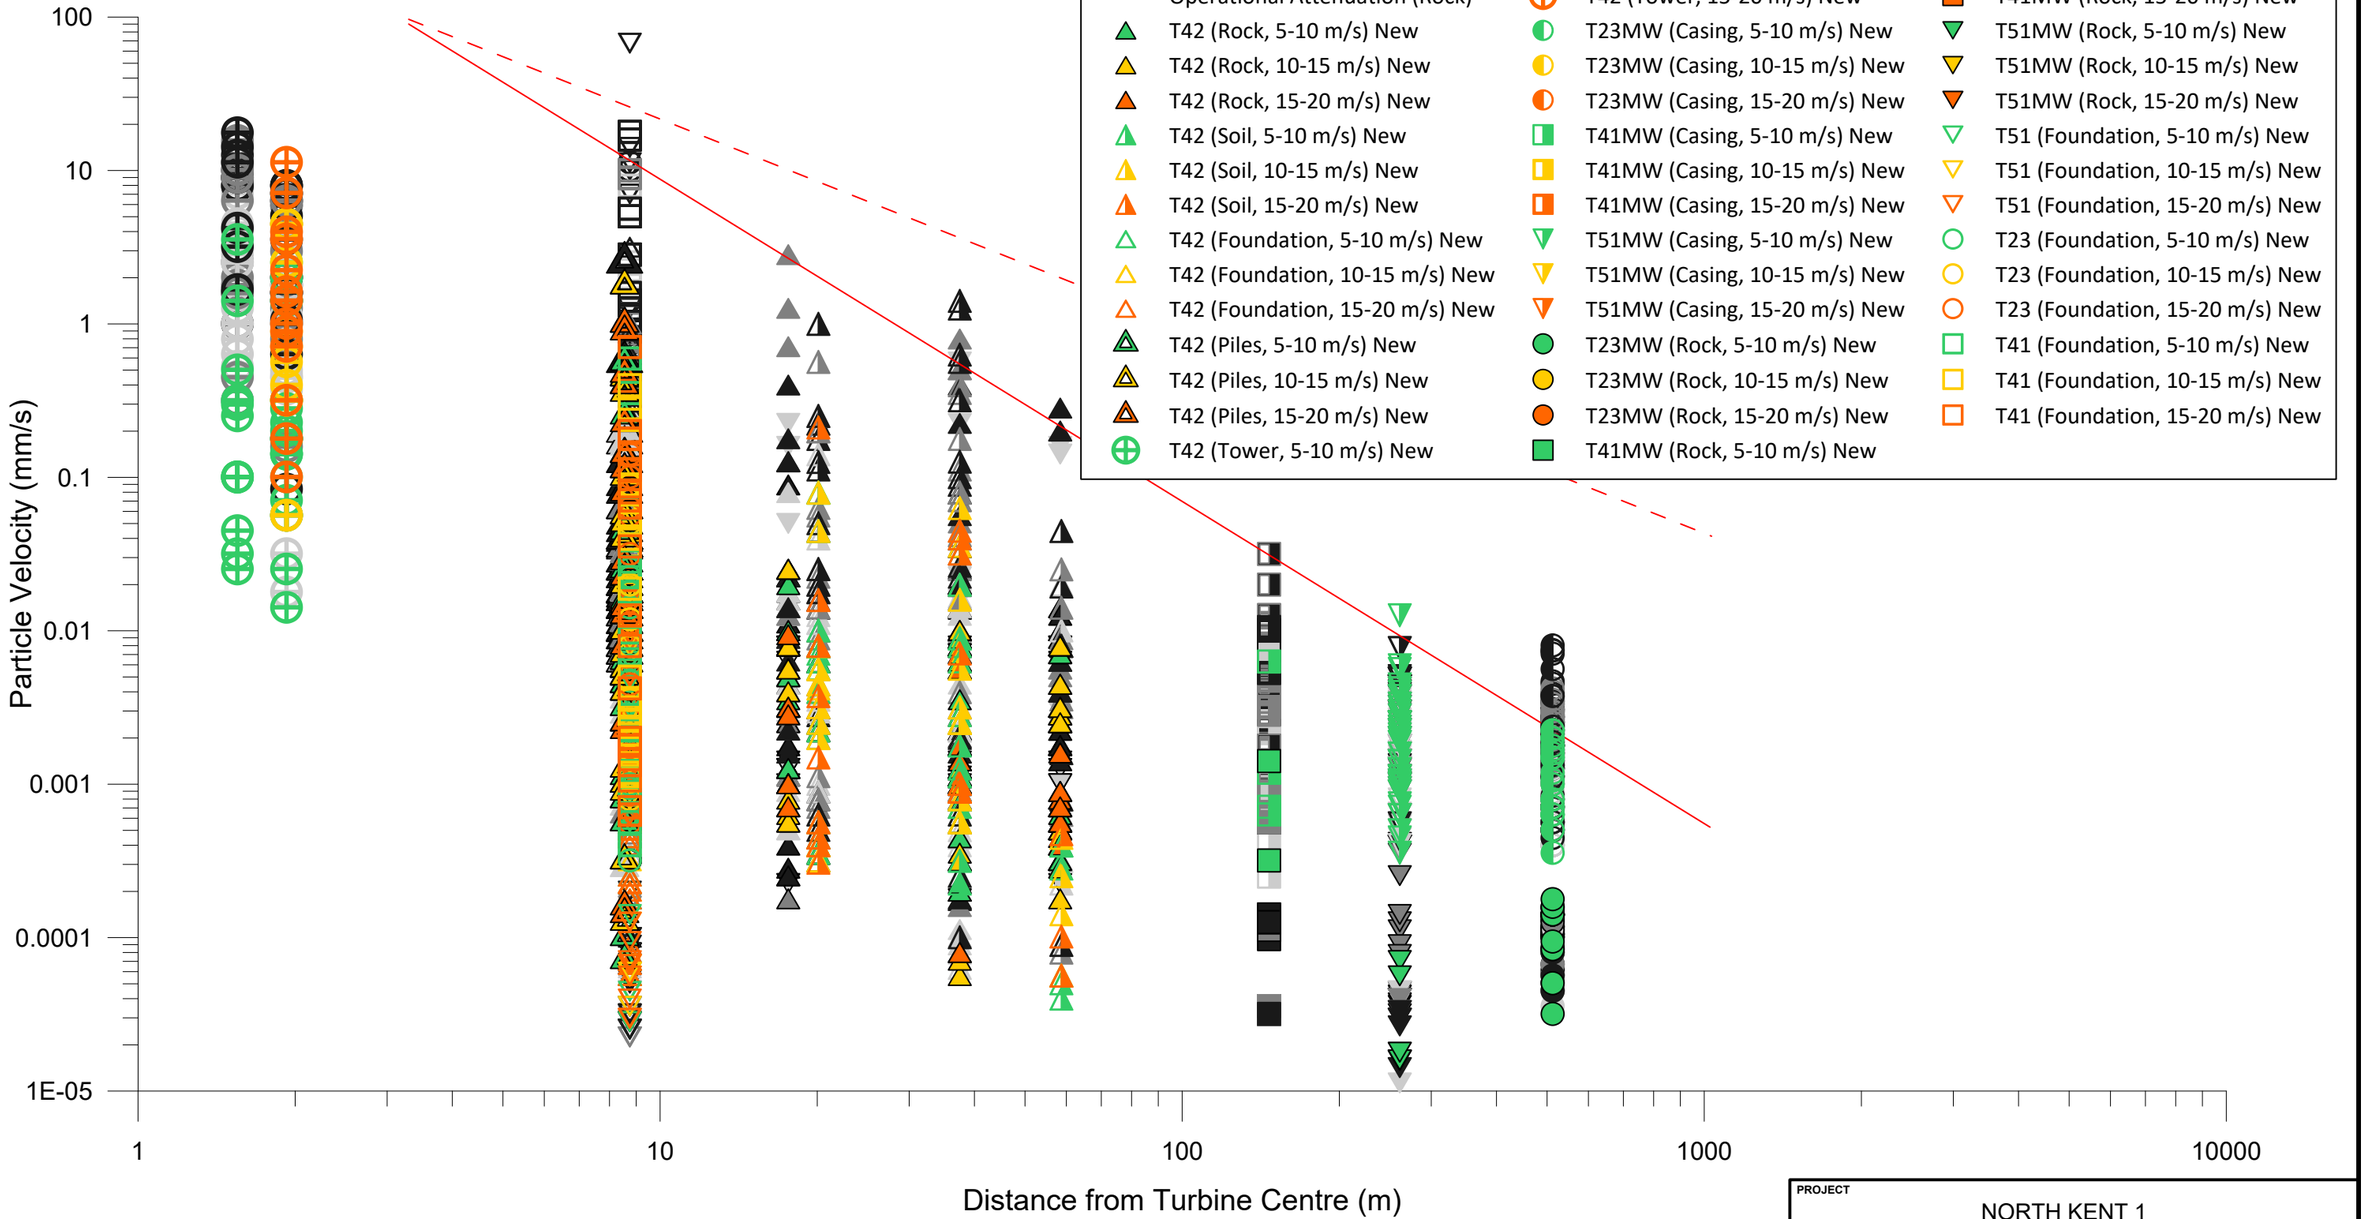
FIGURE 9A

Figures 9A through 9D illustrate the analysis of data collected from the uniaxial accelerometers at the mock wells. As illustrated on these figures and as summarized in Tables 6 and 7, the vibration magnitudes at the top of the mock well casings (i.e., near ground surface) were greater than those within the rock. Typically, vertical responses in the rock were about 1/5th to less than 1/100th of those at the mock well casing tops and less than 1/5th, 95 per cent of the time. Vibration magnitudes measured in the horizontal direction were also greater than those in the vertical direction. As described in Reports No.1, No.2 and No.3, these observed relationships are attributed to the following factors:

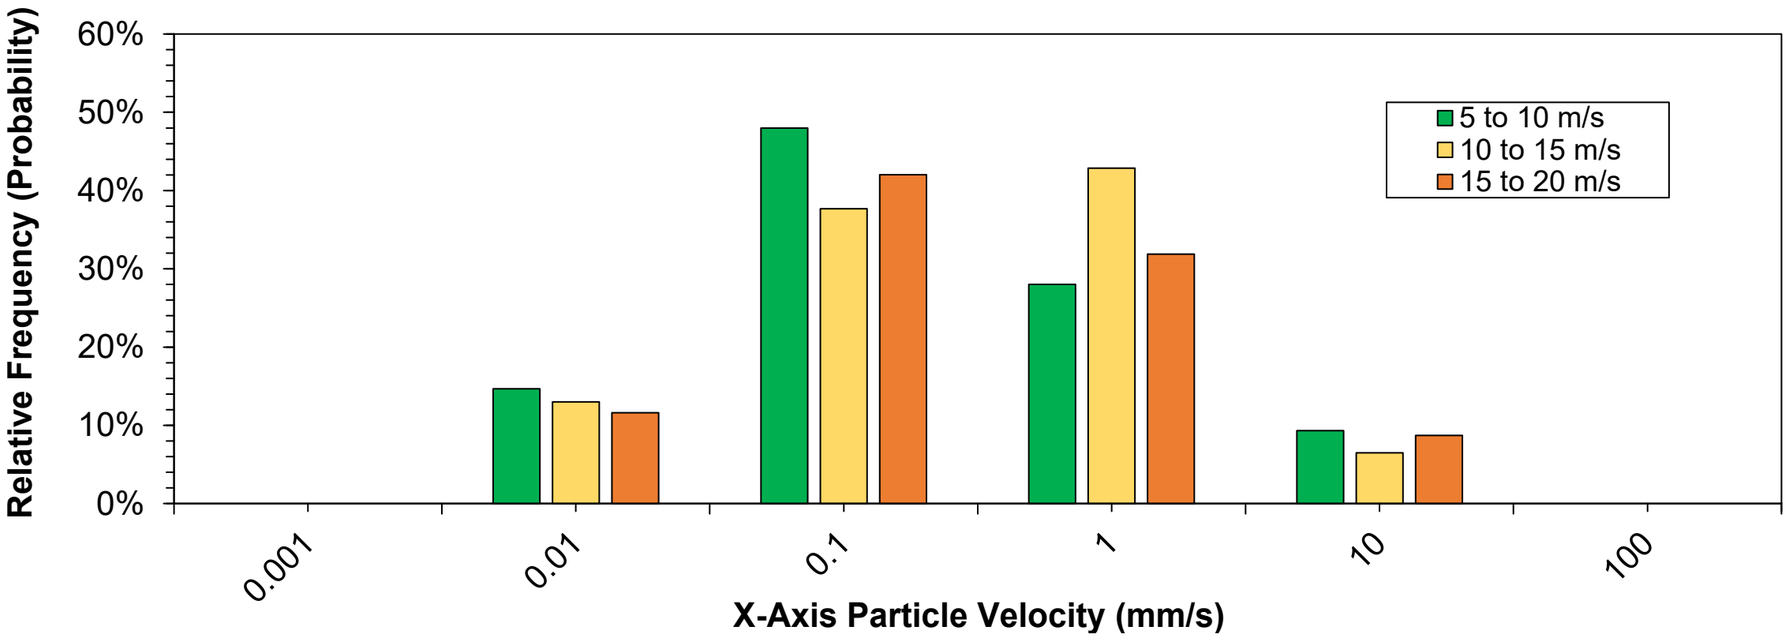
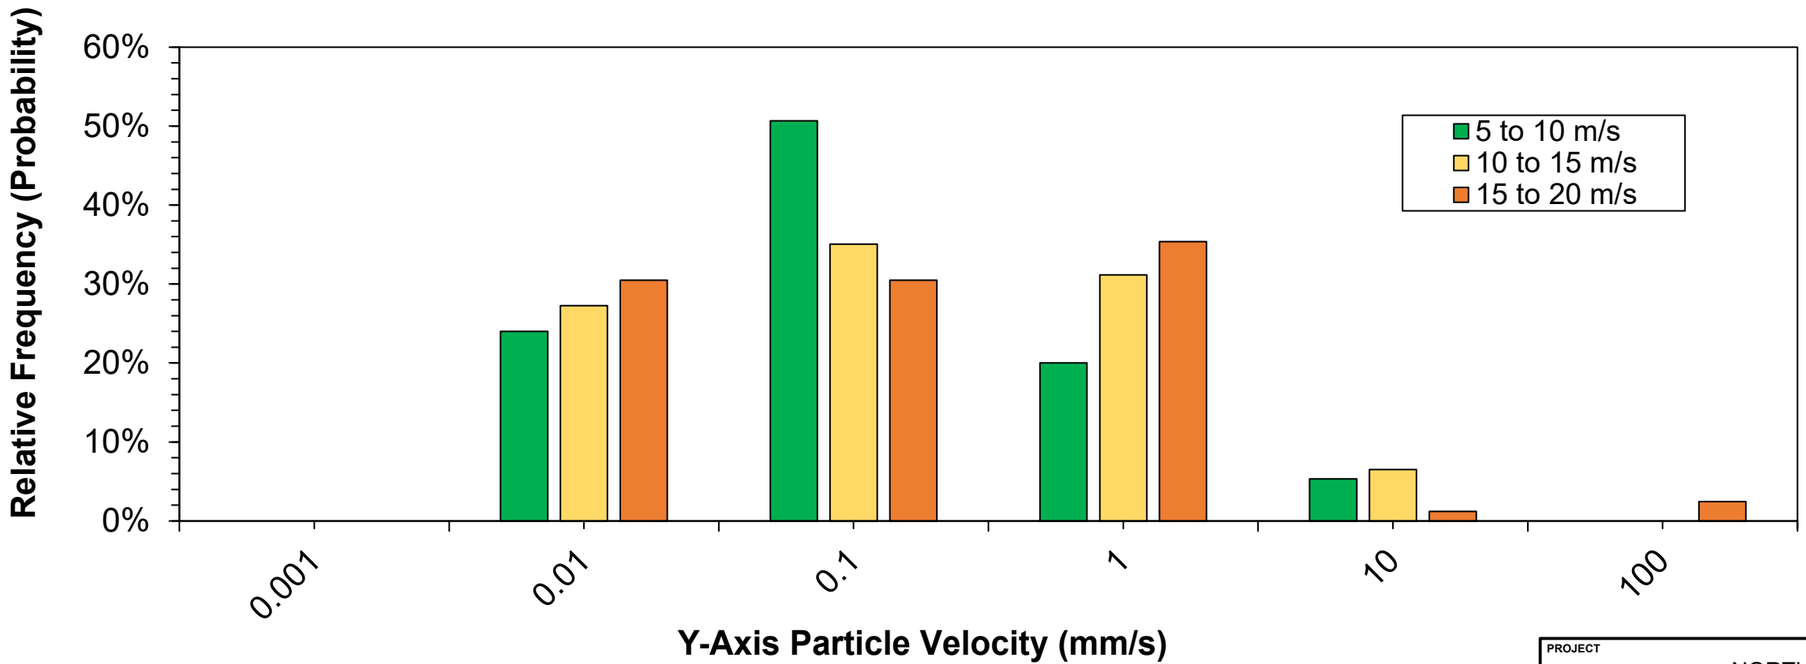
FIGURE 10A

Figures 10A and 10B illustrate histograms of particle velocity measured on the turbine foundations as compared to the wind velocity categories associated with the 10-minute interval meteorological data. Data from the triaxial accelerometers mounted on the turbine foundations was selected for this comparison since, by coupling of the foundation with the ground, the foundations would be the source of ground vibrations away from the turbine. In general, if foundation particle velocity is directly and strongly correlated to wind velocity, these histograms should show more frequent measurements (higher bars in the histograms) of stronger ground particle velocities (bins to the right in the histograms) being associated with the stronger wind velocity categories (i.e., the histogram bars would cluster toward the left for the low wind velocities – green category – and to the right for high wind velocities – orange category). While some rightward shift in the foundation particle velocity histograms can be seen, this shift and the inferred relationship between wind velocity and foundation particle velocity is not strong. While intuitively a strong relationship between wind velocity and foundation vibration magnitude might be expected, the turbine and blade dynamics are not necessarily proportional to wind velocity, particularly at higher wind speeds. Golder understands that above a wind velocity of approximately 14 to 15 meters per second, the turbine blades are feathered (the pitch of the blades is changed) to result in a constant power output and blade rotational velocity remains constant. Given this control of the turbines and their blade angles, the components that might respond directly to changing wind velocity are only the exposed faces of the towers and nacelle. Therefore, the relatively weak relationship between measured foundation particle velocity and wind velocity is consistent with the design and operational characteristics of the turbine.

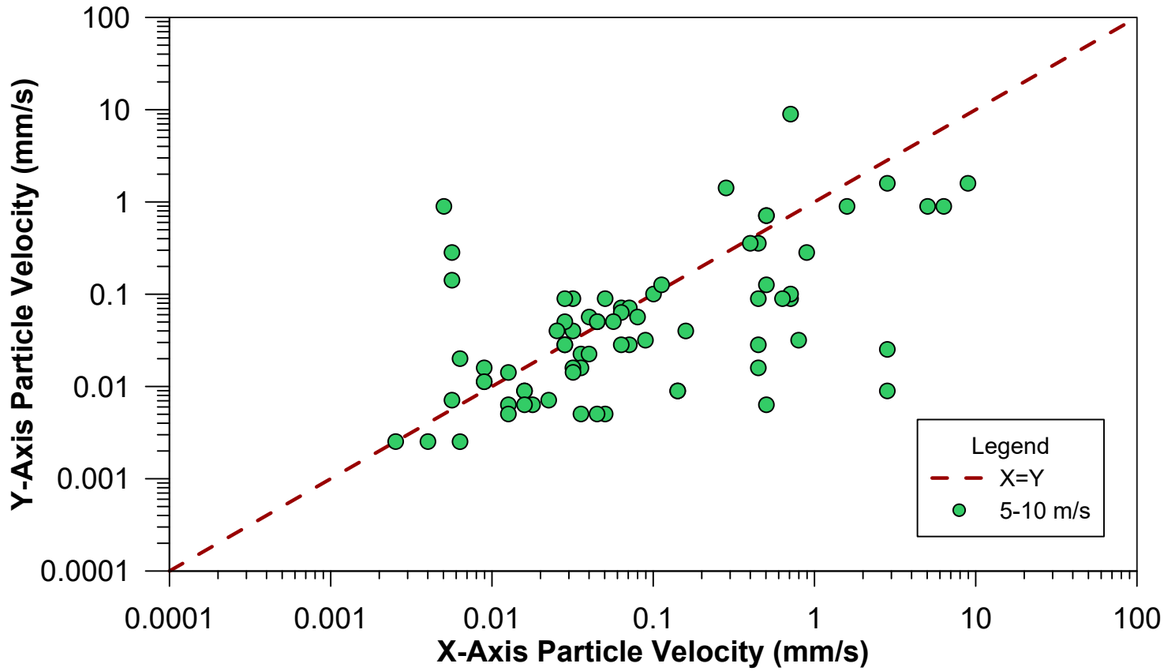
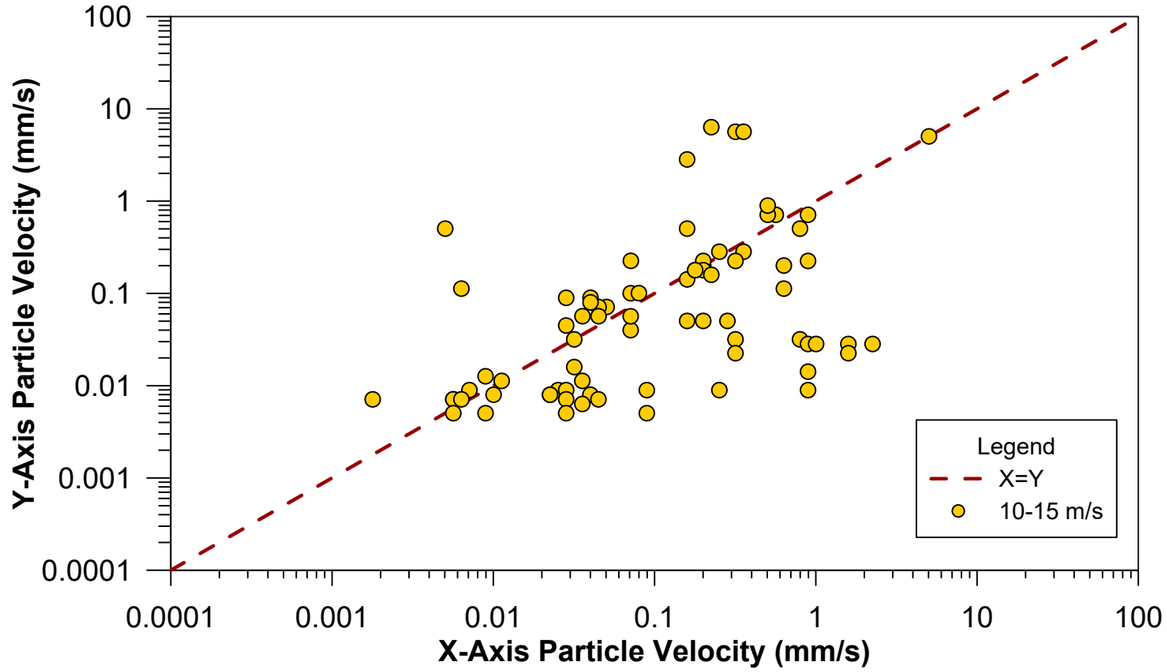
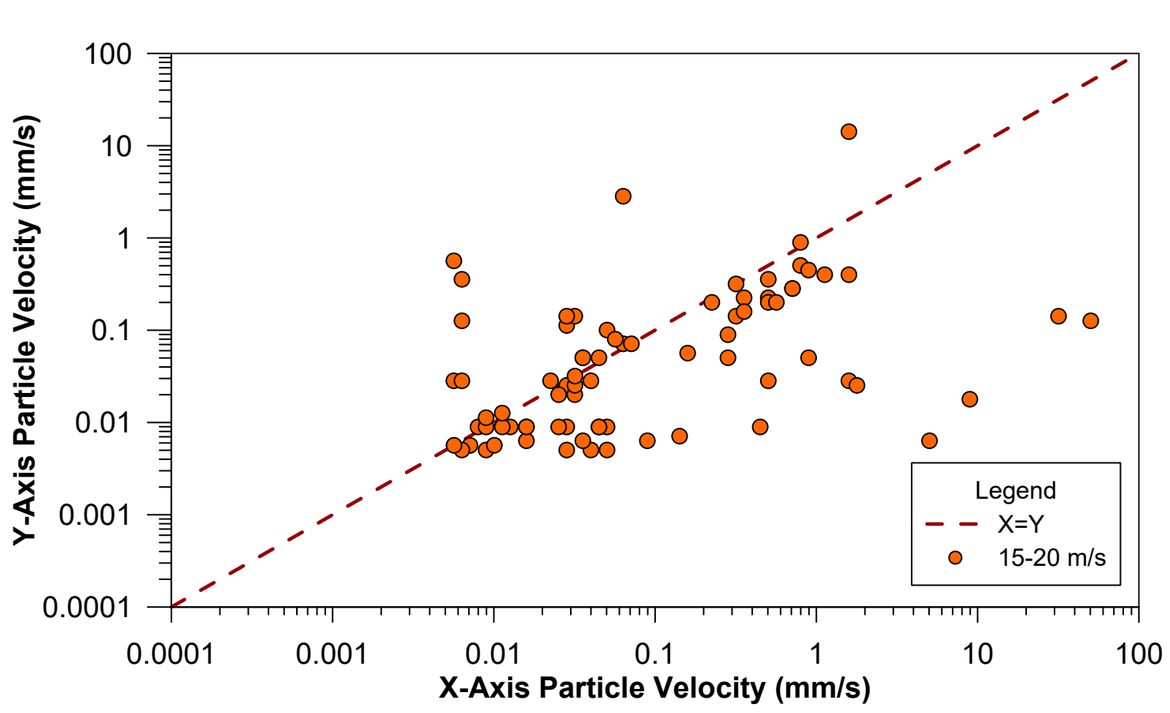
FIGURE 11A

Figures 11A through 11D illustrate a comparison of foundation and mock well particle velocities measured in the horizontal plane. In general, the x axes were oriented to form a direct line between the foundation and nearby mock well with an azimuth ranging between west to west-northwest. The y axis was oriented at 90 degrees to the x axis at each location. For evaluation of mock well responses, data from the uniaxial accelerometers mounted to the

casing top were selected since these produced the best signal to noise ratios, would represent values greater than those measured within the bedrock (because of the effects of soil conditions and casing lengths) and, therefore, would be less likely to produce equivocal comparisons. For both the foundation and mock wells, the data illustrated in Figures 11A through 11D indicate that ground vibrations tend to be somewhat stronger in the x direction, consistent with prevailing wind velocity and direction trends (see Figure 7 in November 2018 report). Comparisons of Figures 11A and 11B to 11C and 11D also illustrate the attenuation of particle velocity magnitudes at the mock wells as compared to the data obtained for the foundations.
