# Technical Memorandum

| Subject | **North Kent Wind 1 (Chatham-Kent, ON)**<br>**Well Water Impact Complaint Investigation – UPDATED v.2**<br>[redacted] **- PIN 007500067,** [redacted] | | |
| Date | November 15th, 2017 | Project No. | 60343599 |

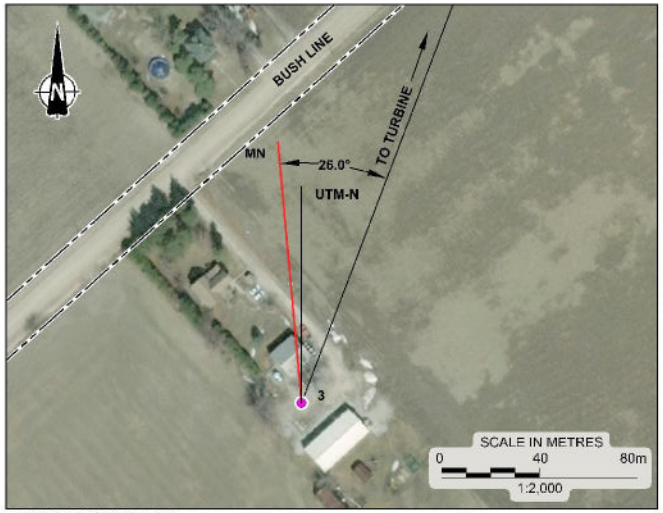
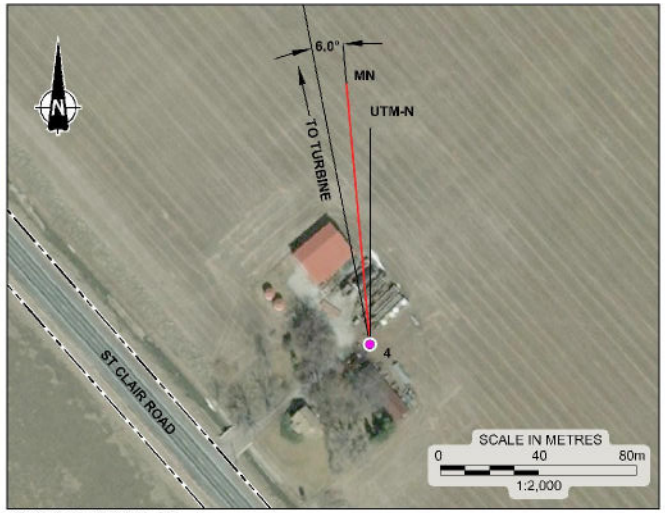
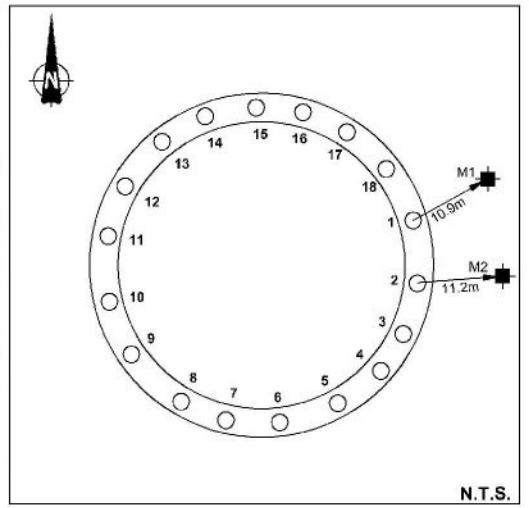
FIGURE T33

At the location of Well 9, monitored during pile driving for T32, specific pile induced vibrations were identified with a magnitude of less than 0.040 mm/s and these were less than those induced by other transient sources of vibration near this site such as traffic and other utility construction. Other data gathered as part of the Phase 1 test pile vibration monitoring program and other wells monitored during the Phase 2 construction pile driving monitoring program were also reviewed since the ground conditions, pile driving systems and pile types and sizes are directly comparable. At distances between pile driving and wells ranging from about 580 m to 911 m, directly

relevant to this water well complaint, maximum vibration velocities related to pile driving ranged from 0.003 to 0.030 mm/s. Vibration velocities at the well for which the complaint was reported would have been within this range. These measured well casing vibration magnitudes are consistent with expected vibration magnitude and distance attenuation relationships and less than the magnitudes anticipated based on the Phase I test pile driving evaluation.
